Summer Village of Sandy Beach

Lagoon Water Release

Operational Plan

Report No. 1803471

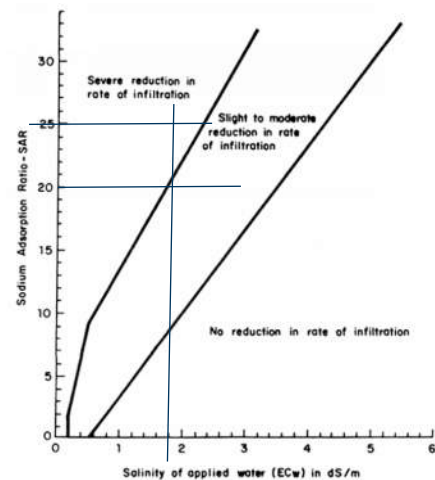
The relative rate of water infiltration as affected by salinity and sodium adsorption ration is provided in the figure (Source: Food and Agriculture Organization <http://www.fao.org/3/T0234E/T0234E04.htm>).

The salinity or Electrical Conductivity of Water is 1.86 dS/m. At SAR of 25, the water will cause sever reduction in rate of infiltration; which can have a detrimental impact on the vegetation as the water wouldn't be available to the root zone for evapotranspiration by plants; however it will evaporate quickly as it would stay on top of grund surface. This may also have beneficial impact on groundwater as the water wouldn't infiltrate into the soils.

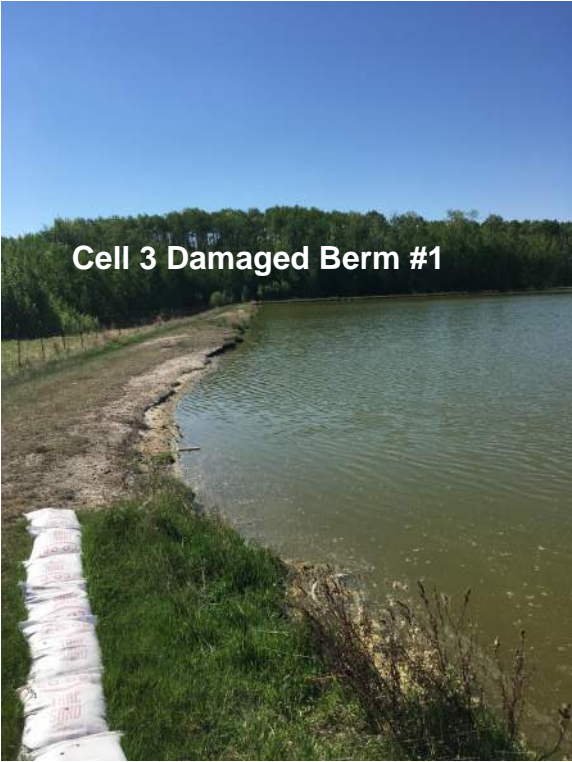
Cell 3 Damaged Berm #1

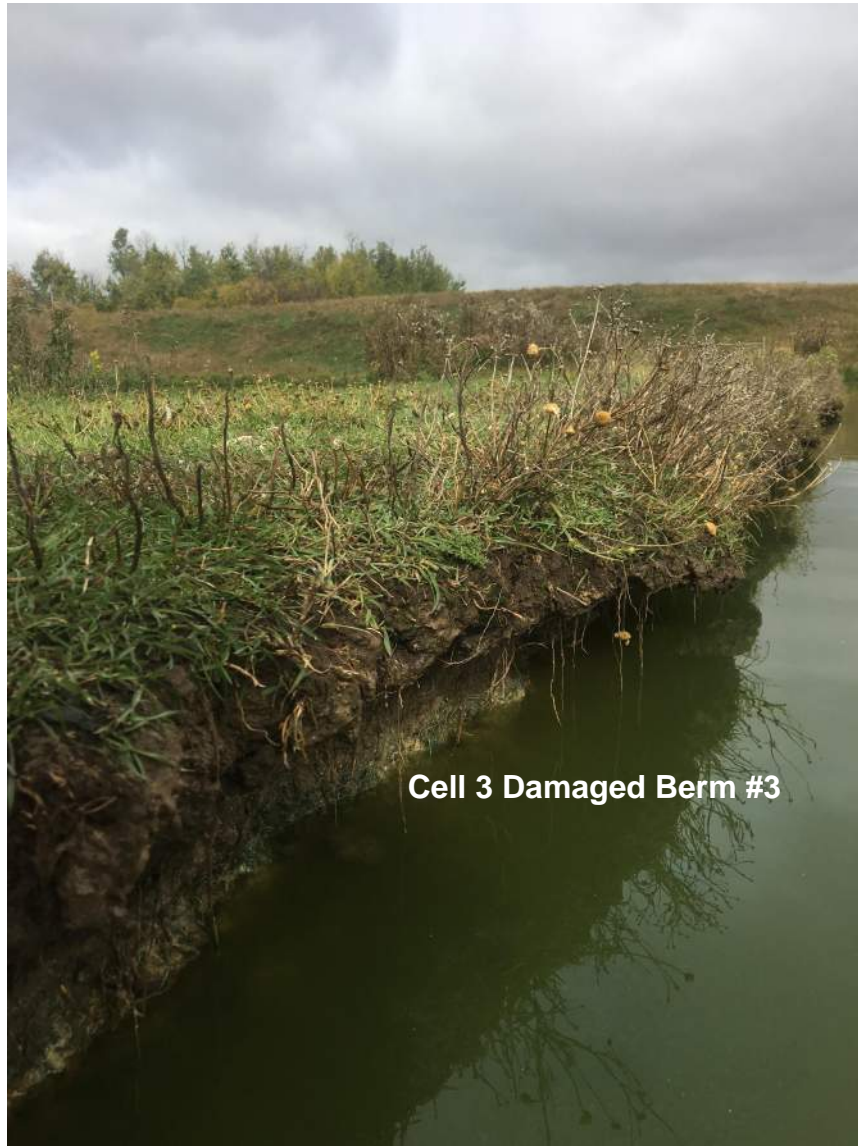
Cell 3 Damaged Berm #3

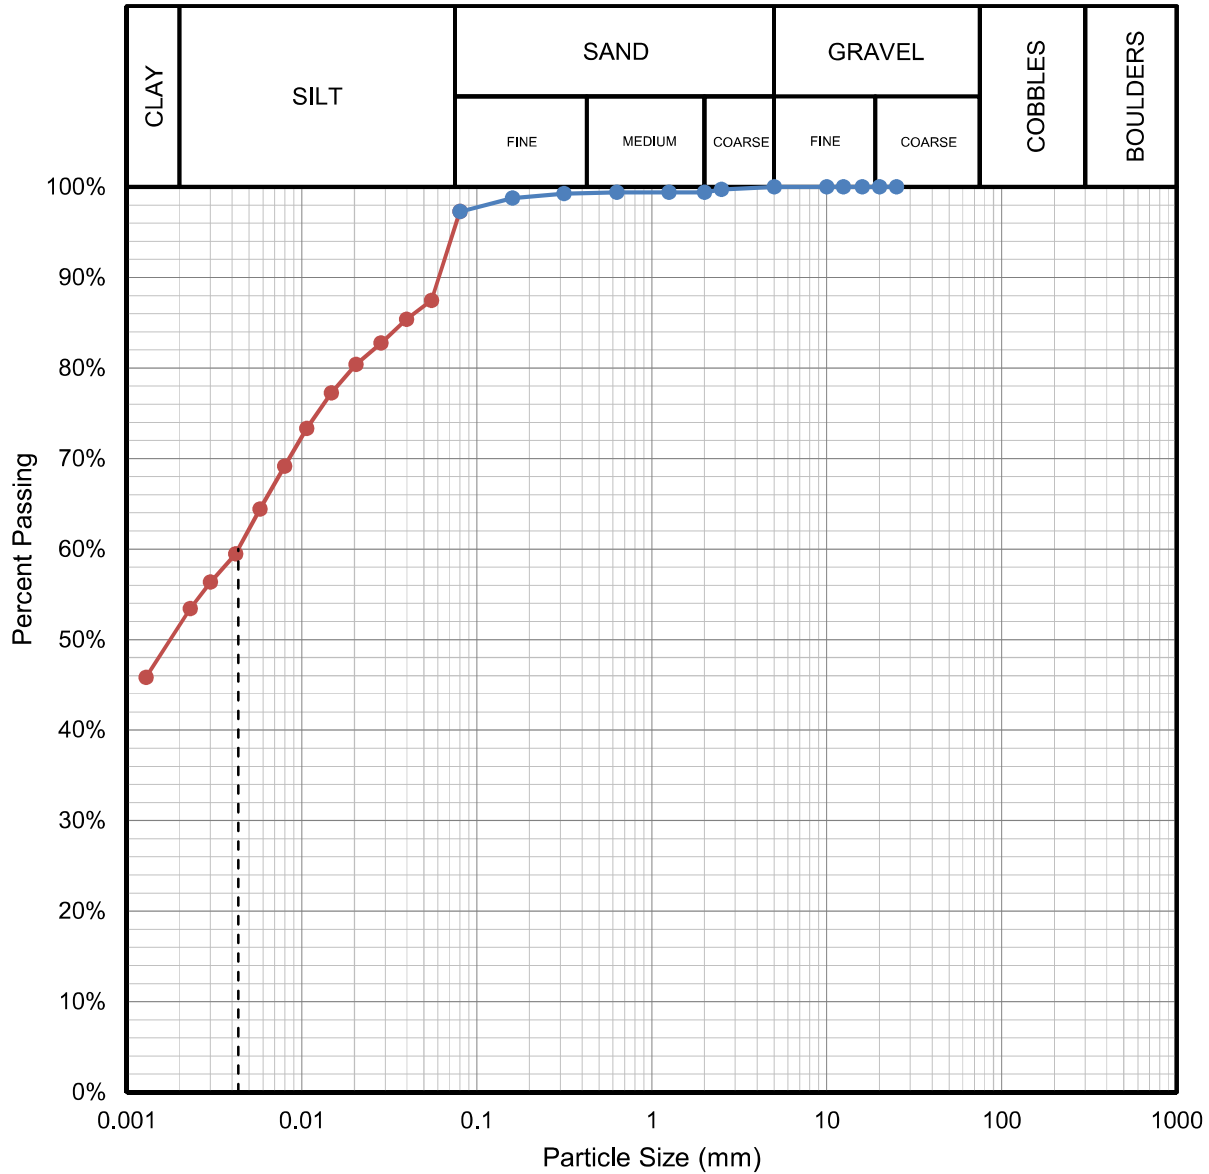
SOIL DESCRIPTION: clay, and silt, trace sand

DEPTH: 2.0 m

SUMMARY OF RESULTS	Gravel	0.0%
	Sand	4.4%
	Silt	44.0%
	Clay	51.6%

GRAIN SIZE	D ₁₀	---
	D ₃₀	---
	D ₆₀	0.0043 mm
